BIG PINE LAKE ASSOCIATION

2019 ANNUAL MEETING

August 17, 2019

DAM/WEIR DESIGN & PERFORMANCE

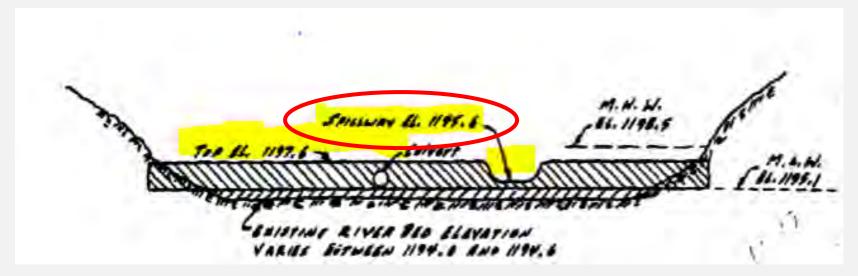
The original rock dam design and permit virtually guaranteed an unusable lake during low inflow periods

- CWC Engineering maintained the dam and spillway to erroneous elevations until September, 2015
- Every breach repair on the east end used loose round rocks which increased dam porosity and leakage

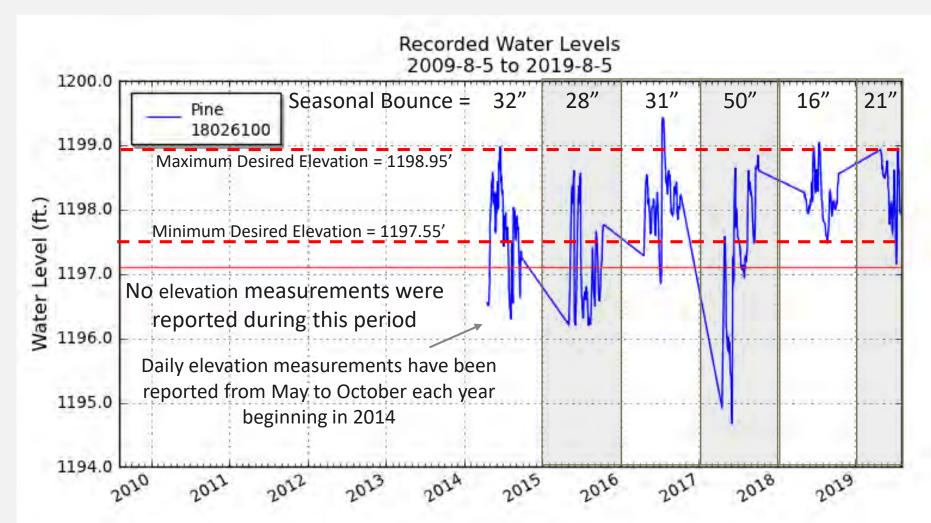
Daily elevation measurements for Big Pine Lake are reported to the DNR and shown in their Lake Finder website over a 10 year period

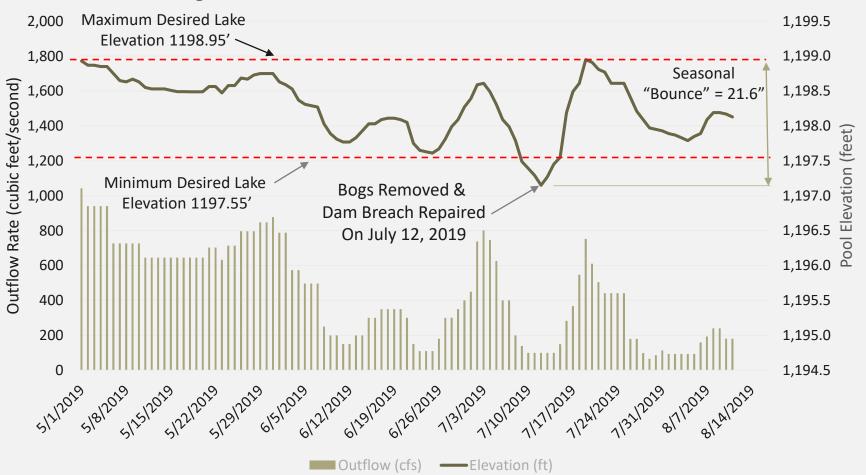
Big Pine Lake Elevation vs. Pine River Dam Outflow

Recent Performance: Lake Elevation vs. Pine River Dam Outflows – May 1 to August 16, 2019

Linear relationship of elevations to inflows >150 cfs shifted after dam repair on July 12

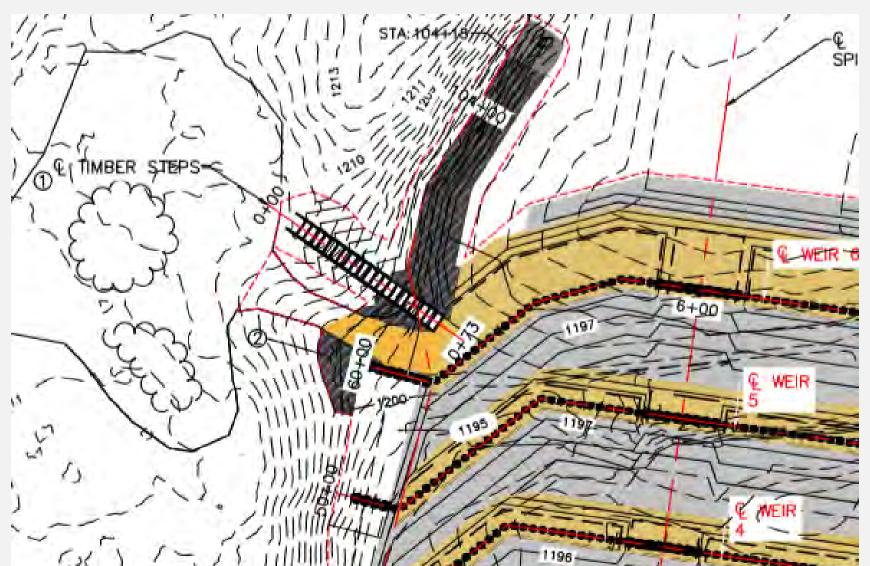
Timber Steps from Parking Area and Bog Retrieval Path in front of Weir 6

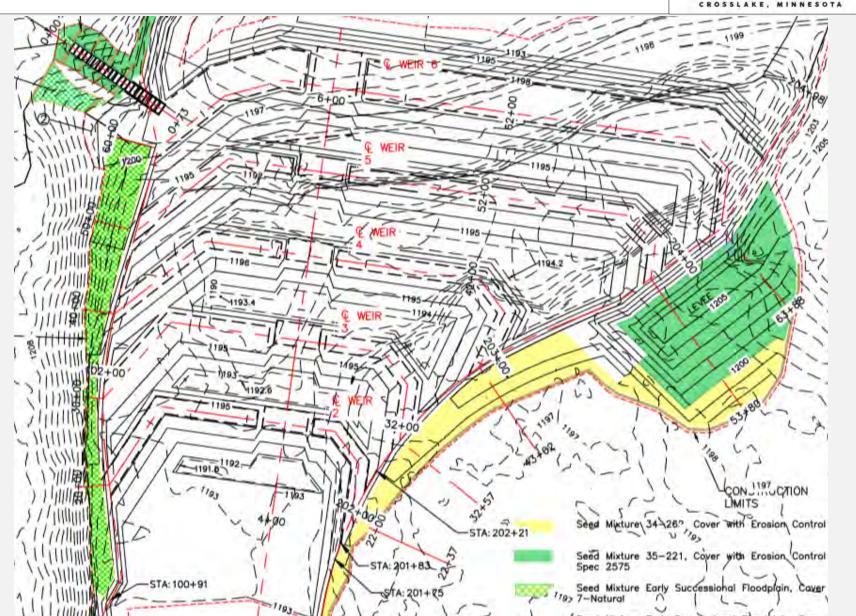
Grassy Walkway along West Bank

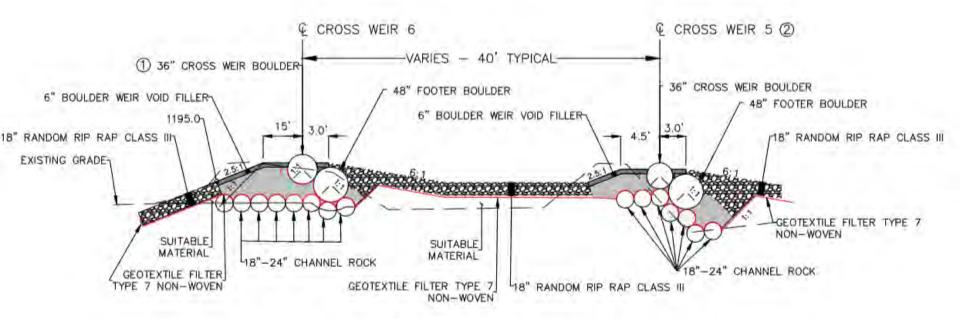
Cross Section of Weirs 5 & 6 showing robust construction and fish resting pool

- ① 36" CROSS WEIR BOULDER ELEVATION SHALL BE 1198.3 IN SPILLWAY AND 1198.6 OUTSIDE OF SPILLWAY.
- ② € CROSS WEIRS 2 THRU 4 ARE SIMILAR TO € CROSS WEIRS 5 & 6. SEE CROSS SECTION AND PLAN FOR ELEVATIONS OF WEIRS.

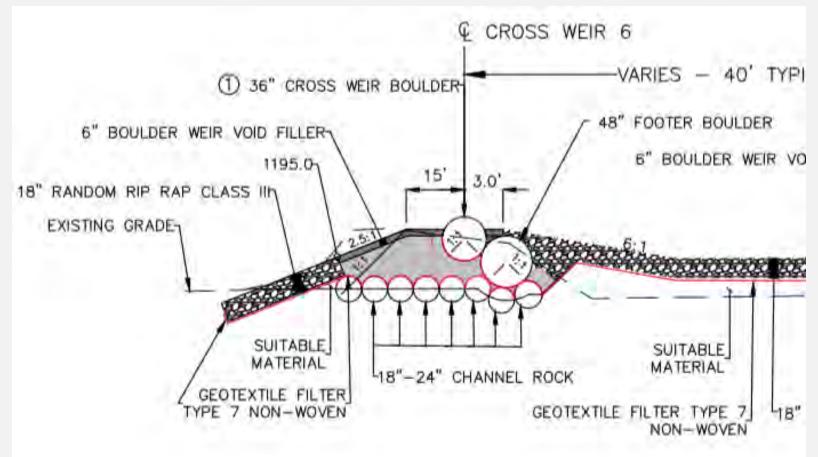
Cross Section of Weir 6 showing durable water control surface and bog retrieval path

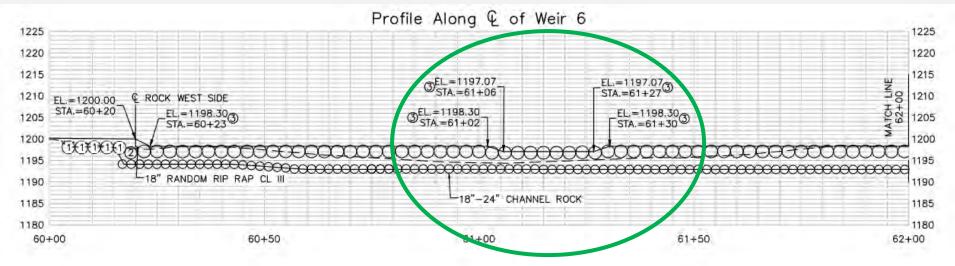
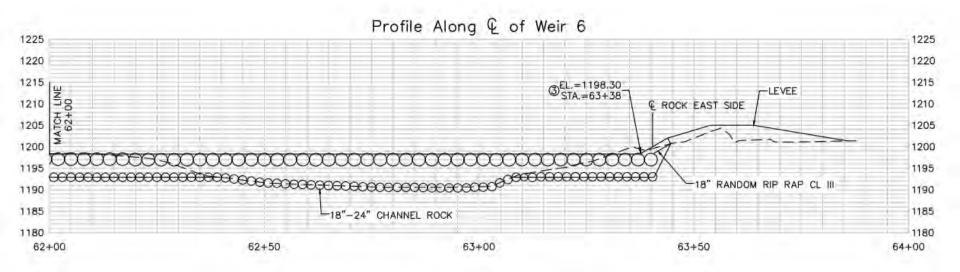
Profile View of Weir 6 showing precision placement of water elevation control rocks

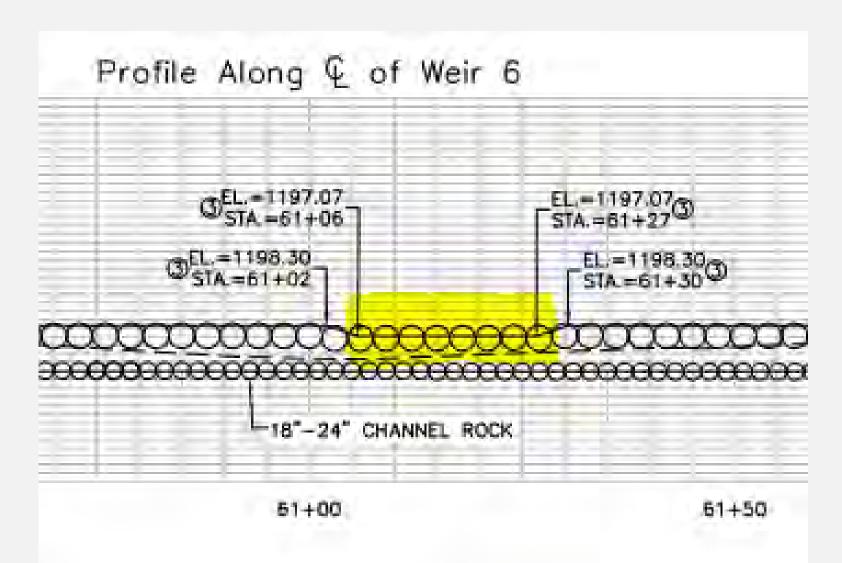
Weir 6 should provide adequate fish passage and maintain our Minimum Desired Lake Level of 1197.55' during periods of minimum inflow

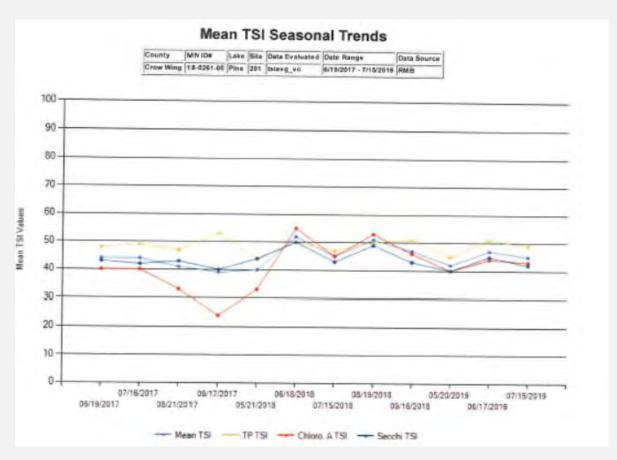
Big Pine Lake TSI Trends

TSI or Trophic State Index: A measurement of overall lake productivity (nutrient enrichment). The overall TSI of a lake is the average of the TSI for phosphorus, chlorophyll-a and secchi depth.
